RESULTS OF THE SECOND U.S. MANNED SUBORBITAL SPACEFLIGHT JULY 21, 1961

**MANNED SPACECRAFT CENTER
NATIONAL AERONAUTICS
AND SPACE ADMINISTRATION**

This document presents the results of the second United States manned suborbital space flight. The data and flight description presented form a continuation of the information provided at an open conference held under the auspices of the National Aeronautics and Space Administration, in cooperation with the National Institutes of Health and the National Academy of Sciences, at the U.S. Department of State Auditorium on June 6, 1961. The papers presented herein generally parallel the presentations of the first report and were prepared by the personnel of the NASA Manned Spacecraft Center in collaboration with personnel from other government agencies, participating industry, and universities.

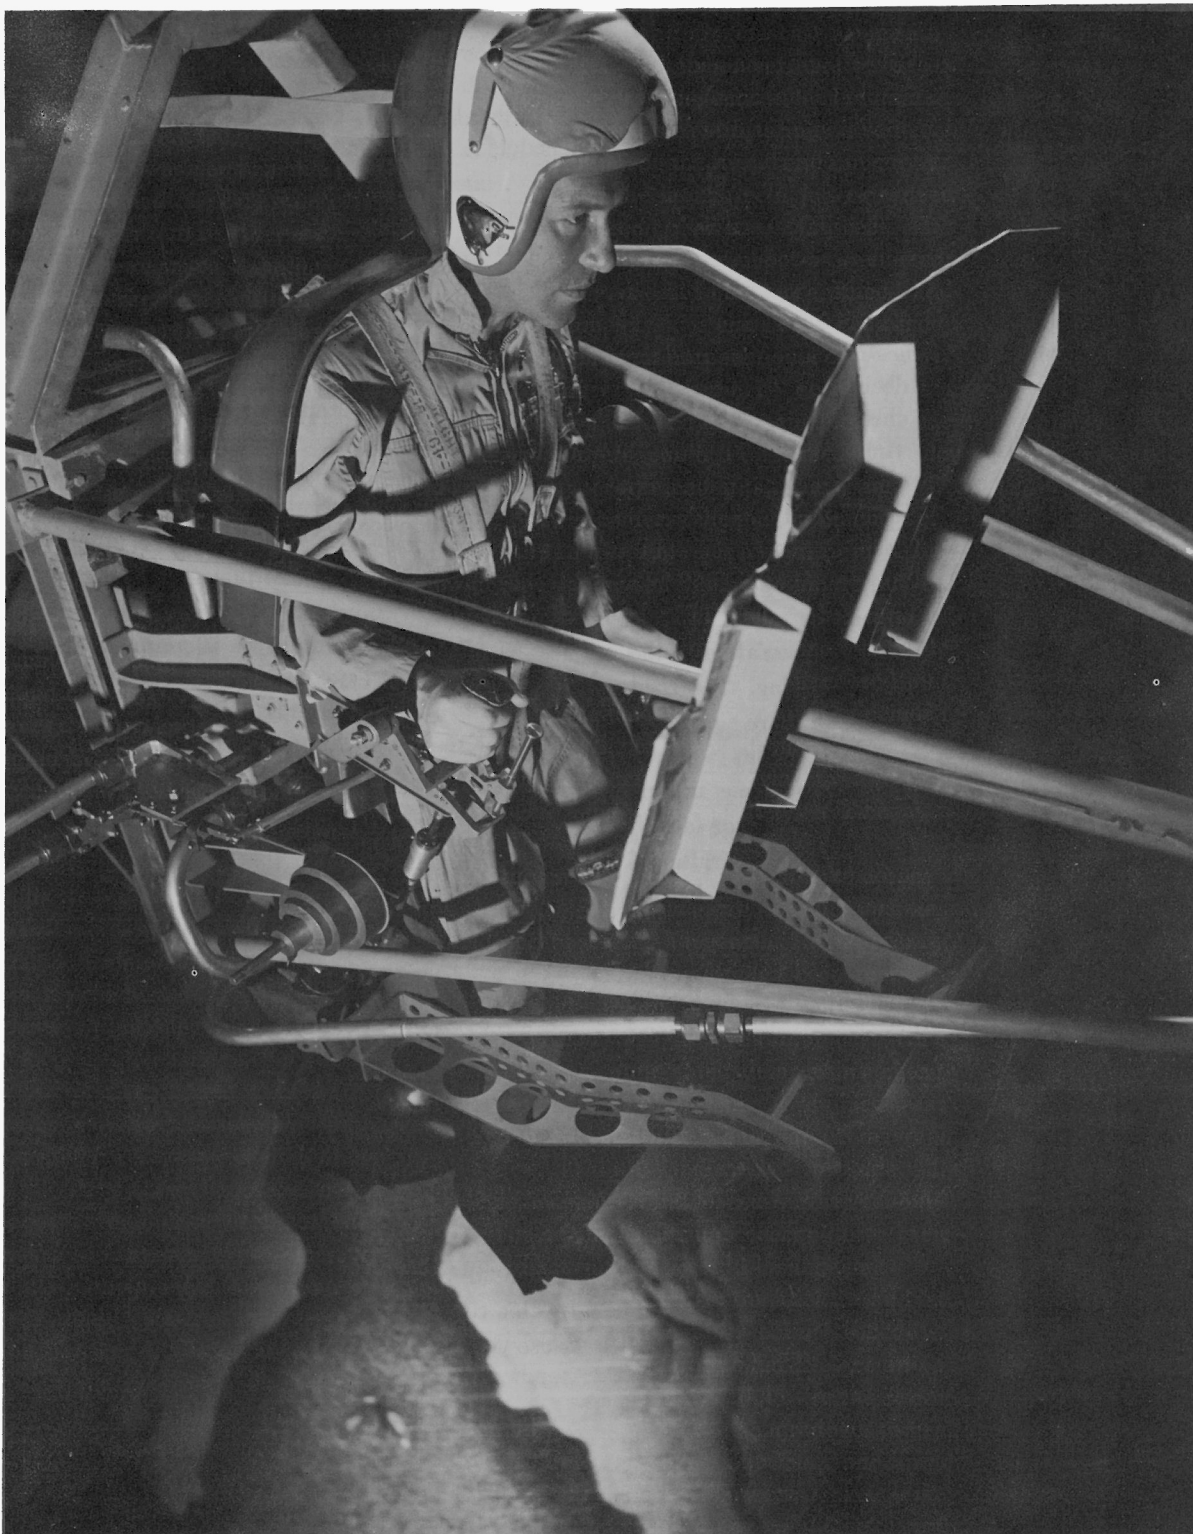
FIGURE 7-3. ALFA trainer.

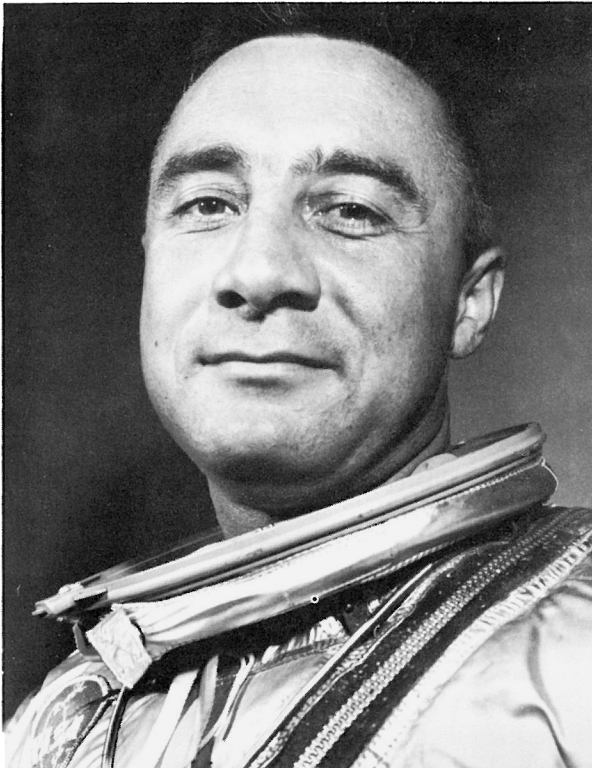
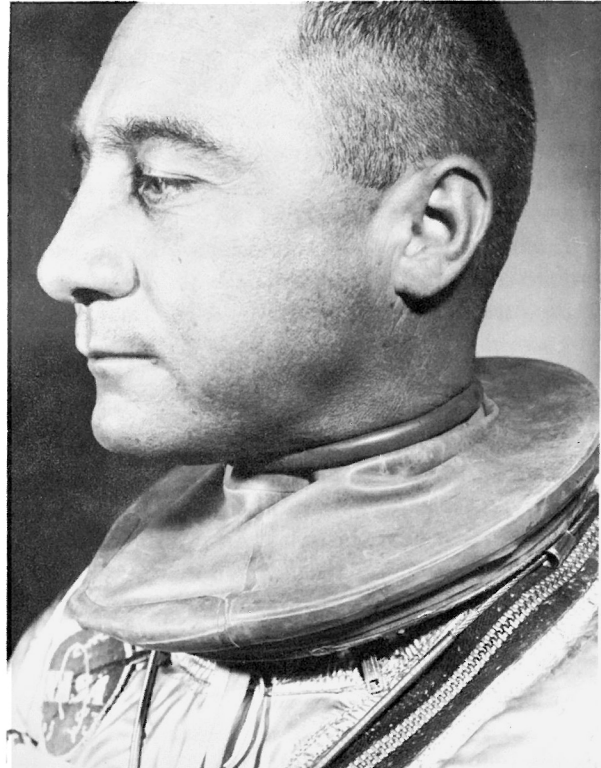
(a) Normal stored position.

(b) Unrolled position.

FIGURE 7-6. Neck dam.

I felt that I was in good condition at this point and started to prepare myself for egress. I had previously opened the face plate and had disconnected the visor seal hose while descending on the main parachute. The next moves in order were to disconnect the oxygen outlet hose at the helmet, unfasten the helmet from the suit, release the chest
